Manhole Inspection Summary

Manhole # S45E2_003MH

Insp Date: **1/25/08 10:57 AM**

Location Address: **Pascal Ave.**

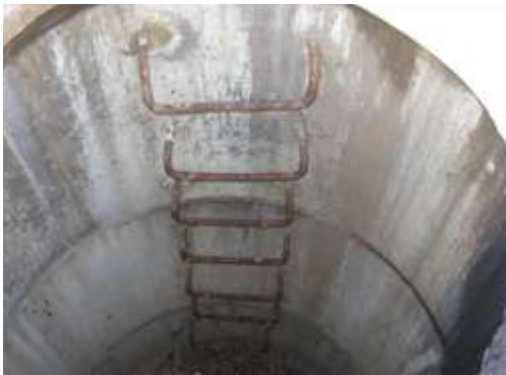
Steps

Count: **7** Missing: **0** ☐ Corroded

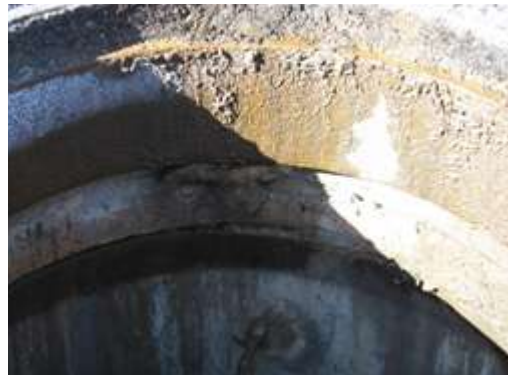
Defect 1

Infiltration: ☐ None ☐ Joint ☒ **Cracks** ☐ Mortar ☐ Roots ☒ **Wall**

Chimney

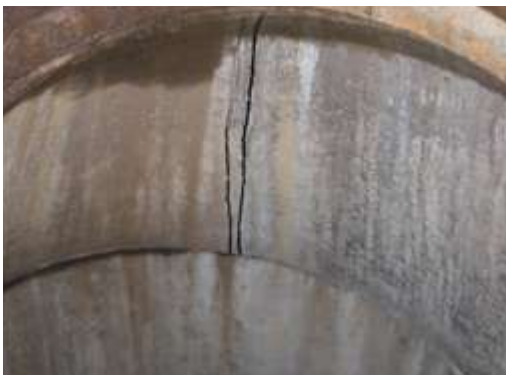
Defect 2

Cracks

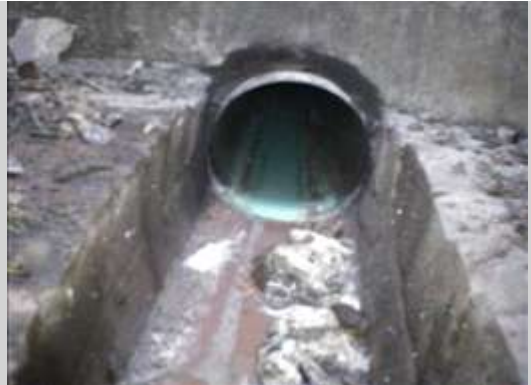
12 O'Clock Outflow

8 in. Circular Gravity Sewer
Pipe Out @ 12 O'Clock

Pipe Height: **9.6** (in.) Rod and Bar (Angled)
Pipe Material: **PVC** ☐ Pipe Lined
Invert Depth: **9.97** (ft.) Flow Characteristics: **Fast**
Deposits: ☒ None ☐ Mud ☐ Sludge ☐ Debris ☐ Grease
Silt Depth: (in.) Deposits Extent:
Infiltration: **None** Pipe Seal Cond: **Sound**

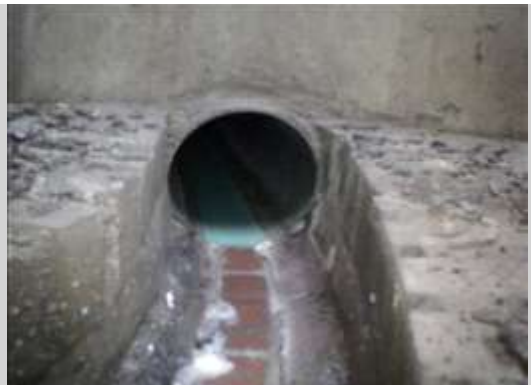
5 O'Clock Inflow

8 in. Circular Gravity Sewer
Pipe In @ 5 O'Clock

Pipe Height: **10.8** (in.) Rod and Bar (Angled)
Pipe Material: **PVC** ☐ Pipe Lined
Invert Depth: **9.95** (ft.) Flow Characteristics: **Fast**
Deposits: ☒ None ☐ Mud ☐ Sludge ☐ Debris ☐ Grease
Silt Depth: (in.) Deposits Extent:
Infiltration: **None** Pipe Seal Cond: **Sound**
